Safety Alert

9-inch angle grinder kick-back lacerates worker's face and throat

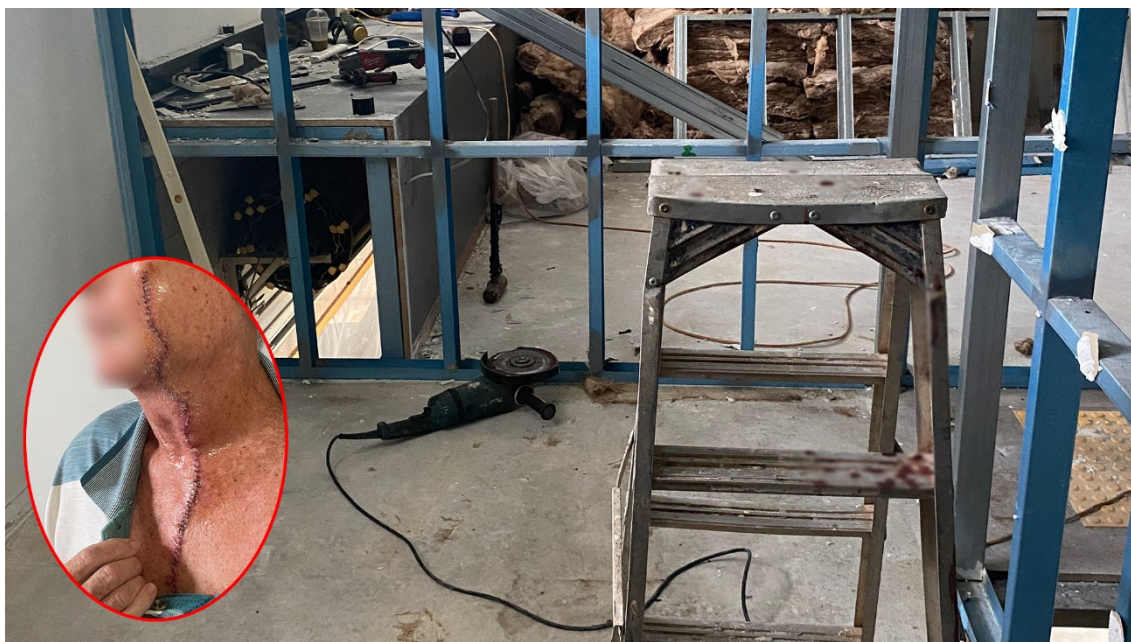
The worker had been using a 5-inch angle grinder to make the initial cuts but switched to the larger grinder to finish the job quicker. The grinder kicked-back causing a laceration that ran from the worker's face, along his throat and into his chest.

Image: The scene in situ after the incident. (Insert) The extent of the laceration suffered by the injured worker.

- The increased power, torque and size of 9-inch grinders makes them more difficult to control compared to smaller grinders or other cutting tools.
- The worker was not in a stable position to control the grinder as he was standing on a ladder with the grinder cutting above his head.
- The metal frame may have sagged due to the previous cuts made and pinched the cutting disk potentially contributing to the kick-back.

- The extension lead the grinder was plugged into had been modified with a 15amp socket attached to a 10amp lead allowing the lead to be overloaded, and subsequently causing burning and a poor connection inside the 10 amp plug.
- Testing by NT WorkSafe showed the poor connection in the 10amp plug may have caused a fluctuation of the electrical current with the grinder unexpectedly stopping and starting, potentially causing a kick-back.

- Carry out a risk assessment to identify alternative tools or methods of cutting before you use a 9-inch (230 mm) angle grinder.
 - Some companies in the Northern Territory and across Australia have implemented voluntary bans of 9-inch angle grinders on their worksites due to the high number of serious injuries and deaths that have occurred.

- Ensure you have proper footing and balance when using a grinder, and you do not overreach. If you are cutting something at height, use an appropriate work platform that allows you to maintain your footing and balance.

- If you are cutting items that are upright or hanging, use props or clamps to prevent the item from sagging and pinching the cutting blade.
- Do not modify the electrical components of power tools or associated leads unless you are qualified. Ensure that the ampere capacity of any electrical leads matches the power requirements of the power tool.
