## Safety Alert

# Apprentice suffers electric shock and falls from roof

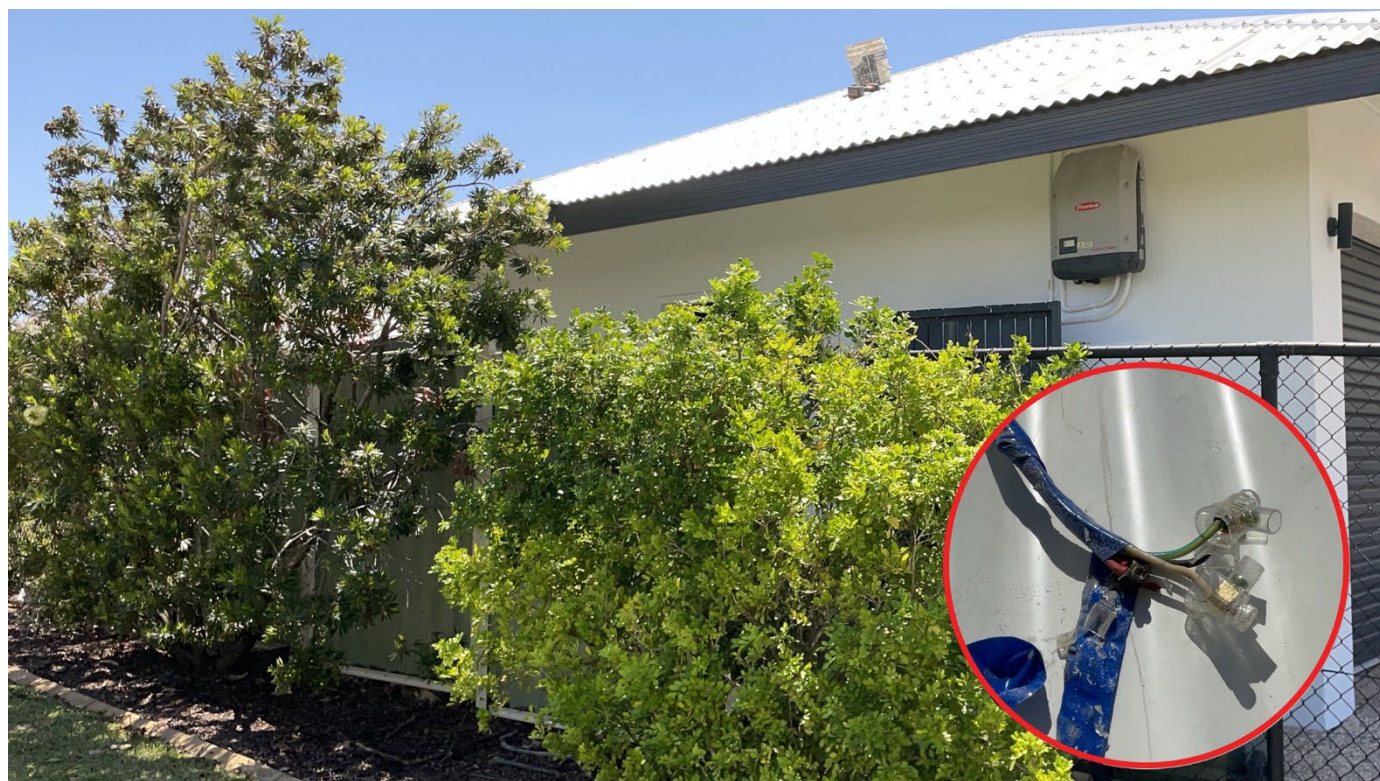
The apprentice received an electric shock and fell off the roof, onto a fence and into the neighbouring yard.

Preliminary findings indicate a connector used to insulate the wiring was damaged, exposing live parts which the apprentice grabbed. WorkSafe Inspectors also found the RCD protecting the circuit had failed.

**Image:** The apprentice fell from the roof, onto the fence and landed in the neighbouring yard after an electric shock. **(Insert)** A connector used to insulate the wiring was damaged, exposing live parts.

- Power was not switched off at the switch board.
- The electrical wiring was damaged with live parts exposed.
- The RCD protecting the circuit had failed.
- The pitch of the roof was steep.
- Fall protection was not used when the apprentice climbed on the roof.

- Always lock out and tag out the switch board and ensure the power is off before entering the ceiling space or handling electrical wiring located in the ceiling space.

- Electrical wiring in ceiling spaces may deteriorate due to high temperatures, or become damaged due to vermin or from sharp objects in roof trusses and ceiling joists, such as protruding screws and nails.

- Supply cables from the solar panels to the inverter unit will also be live when the solar panels are generating electricity.
- When working on a roof or at heights, manage the risk of falls by using:

- a fall prevention device; or
  - if it is not reasonably practicable to provide a fall prevention device, provide a work positioning system; or
  - if it is not reasonably practicable to comply with either A or B, provide an alternative fall arrest system, so far as is reasonably practicable; and

- Home and business owners must test the RCD's fitted to your property regularly. NT WorkSafe recommends testing every three months.
- Press and release the test button on the RCD.
- If the RCD fails to operate, contact a licensed electrical contractor to test and replace the RCD, if required.
