Safety Alert

Gas explosion risk from built-in LP gas barbecues

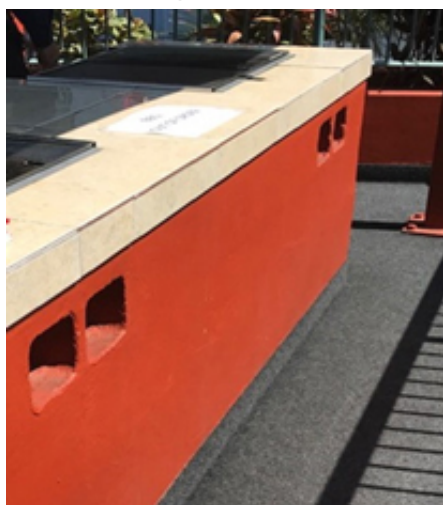
Image 1: Ventilation points at the top still of the compartment still allowed gas to accumulate at the bottom.

- Facility managers and commercial property owners with built-in LP gas barbecue facilities should immediately check their manufacturer's built-in housing design requirements to see if ventilation, installation and operational requirements have been met.
- Gas barbecues that have not been designed by the manufacturer to be installed as a built-in facility should not be used until checked by a licensed NT gasfitter. Contact NT WorkSafe on 1800 019 115 for further information.

- Make sure the barbecue has been designed for built-in installation and make sure manufacturer's built-in housing design requirements have been followed.
- Always use a Licensed NT Gasfitter to install and maintain any gas appliance.
- Ensure the area for the barbecue facility has adequate fresh air and flow through ventilation.
- Do not obstruct the flow through ventilation of a built in LP gas barbecue facility with walls, fences, screens or other barriers.
- Do not store any LP gas cylinders or chemicals or flammable products near or under the built in gas barbecue.
- Do not transport gas cylinders in an enclosed vehicle, unless the vehicle is fitted with a gas cabinet.
- Place signs in the barbecue facility instructing barbecue users to check that all hose connections are secure (if appropriate) and there is no smell of gas before starting the barbecue.

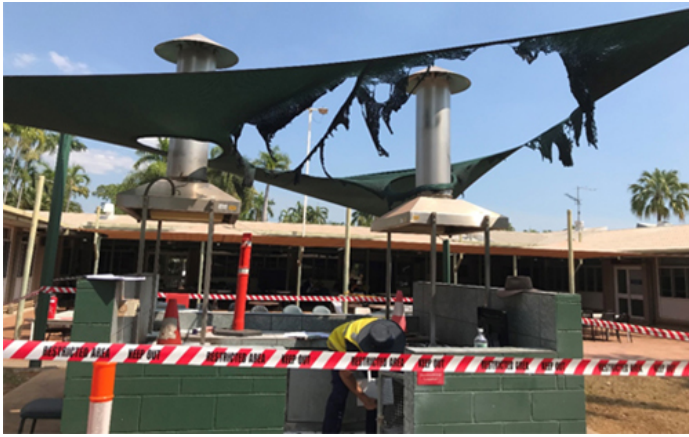
Image 2: The wall enclosing the barbecue facility blocked flow through ventilation allowing gas to accumulate.
