## Safety Alert

# Asbestos identified in Shantui Forklifts

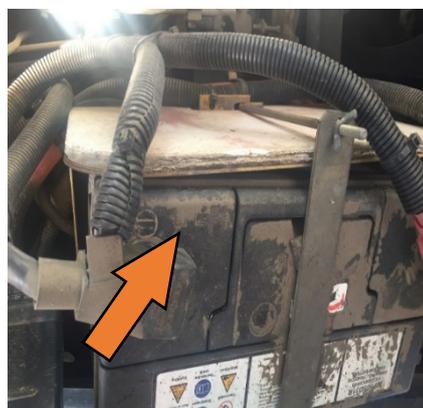
- battery insulation and exhaust gaskets of 3-tonne forklifts
- exhaust gaskets of 5-tonne forklifts, and
- exhaust gaskets and the hydraulic tank gasket of 7-tonne forklifts.

**Figure 1:** Asbestos insulating board above battery

Analysis of the battery insulation material and the gaskets identified fibres of chrysotile asbestos. The fibres are bonded to other material. Any risk from asbestos depends on the extent of asbestos fibre release and inhalation of these fibres, which can be caused by damage to the materials.

It is recommended that users and owners of the forklifts inspect the battery compartment of the 3-tonne Shantui forklift for the presence of fibrous battery insulation material. If found, the forklifts should be isolated from use and a competent person trained in the identification and safe handling of asbestos (for example a Certified Occupational Hygienist, Licensed Asbestos Assessor or Licenced Asbestos Removalist) should be engaged to have a sample of the material analysed for the presence of asbestos.

If asbestos is confirmed within the battery heat insulation material, a competent person (Licenced Asbestos Removalist) trained in the safe handling and application of suitable controls measures for carrying out asbestos-related work should be engaged to remove the asbestos material in accordance with the [Code of Practice – How to manage and control asbestos in the workplace](#). It is also recommended that a clearance certificate be obtained from a competent person after removal. Consultation should be held with the forklift manufacture regarding a replacement heat insulation material.

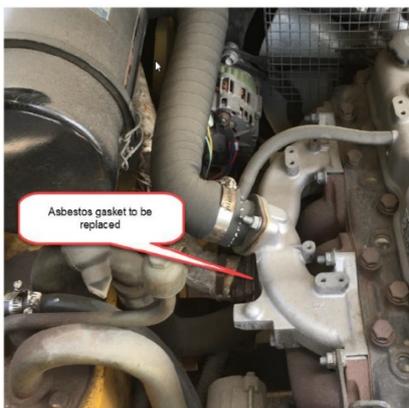
**Figure 2:** Exhaust manifold gaskets

The identified gaskets of the Shantui 3-tonne, 5-tonne and 7-tonne forklifts should be assumed to contain asbestos. Components identified with asbestos must only be removed by a person who is competent to do so safely. Appendix E of the SWA code of practice provides an example of a “working with asbestos friction materials” safe work method that can be used, including appropriate personal protective equipment, decontamination and disposal of the asbestos waste.

Spare gasket materials of the same brand should also be assumed to contain asbestos unless testing confirms no asbestos is present. Alternatively, the spare gaskets can be disposed of as regulated waste and replaced with gaskets that are certified as asbestos free in accordance with Australian requirements.

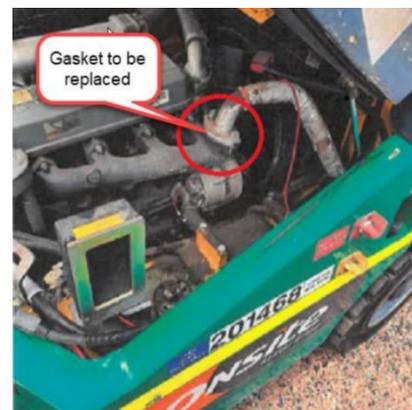
**Figure 3:** Exhaust manifold gaskets

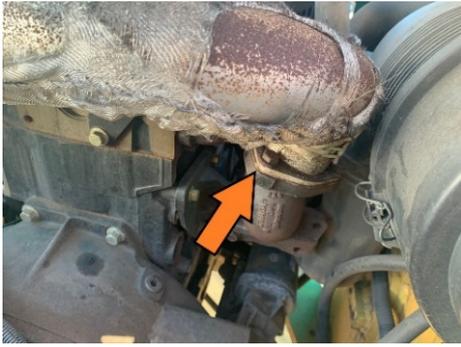
**Figure 4:** Exhaust flange gasket

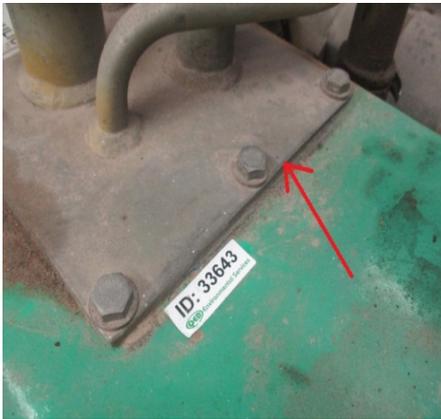
**Figure 5:** Hydraulic tank gasket

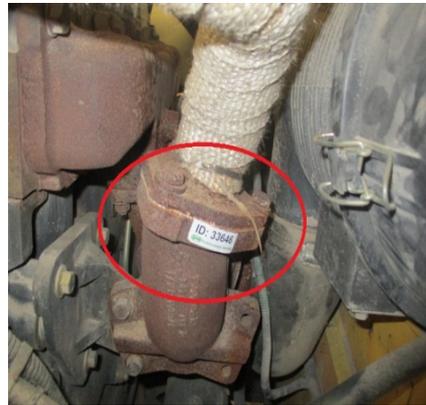
**Figure 6:** Exhaust flange gasket
