Fall protection reduces risk of falling overboard

The purpose of this Safety Alert is to highlight the increased risk of an overboard incident when workers are in areas with no edge, or fall, protection.

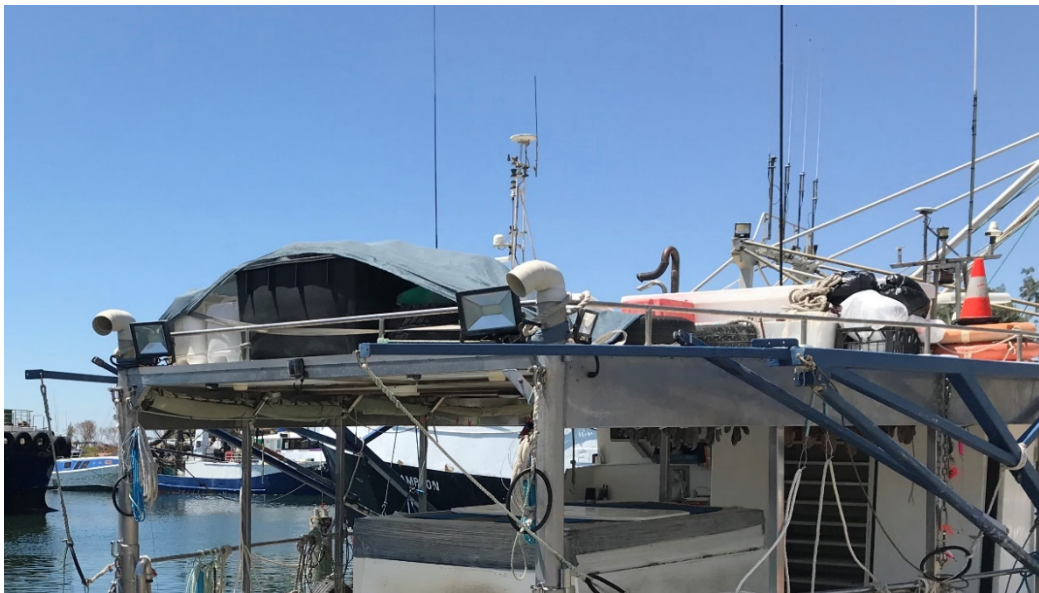
The crew's response was swift and positive with the crew member being retrieved on board. However, unfortunately the crew member could not be revived. NT WorkSafe's preliminary findings established the roof area had no fall protection suitable for preventing a fall.

The roof area had no fall protection suitable for preventing a fall. (Image: AMSA)

- Implement procedures that establish minimum requirements for working at unguarded or elevated work locations where there is a risk of falls;
- Install appropriate fall prevention measures on all elevated areas of a vessel that workers may need to access. If it is not reasonably practical to install edge protection, other forms of fall restraints should be considered;

- If there is a risk of falling overboard, ensure workers wear a lifejacket, and if possible workers should not work alone;
- Ensure elevated areas (such as roof areas) of the vessel are hazard free, have safe access and egress, with provision for three points of contact;
