## Safety Alert

# Asbestos in the brakes of manual hand pallet trucks

The purpose of this Safety Alert is to provide information about the potential presence of asbestos in the brake shoes of manual hand pallet trucks imported from the People's Republic of China (China).

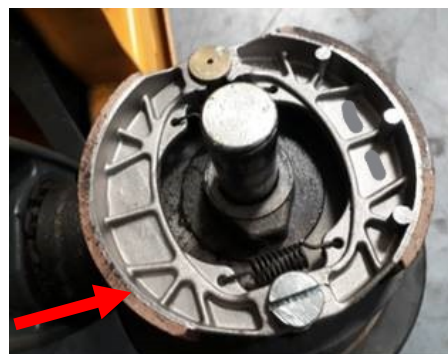
The affected mechanism is a tiller parking brake system with fully enclosed brake shoes within the wheel assembly. Asbestos was located in the brake lining of the shoes as shown.

**Figure 1:** Uncovered brake assembly of an affected manual hand pallet truck

However, if the brakes are repaired, serviced or replaced, there is a risk of exposure to asbestos during the disassembly of the brake shoes. Owners or users of Chinese manufactured manual hand pallet trucks that have concerns about their equipment are advised not to undertake any maintenance, repairs or modifications of the wheels. They should contact the Australian supplier for clarification and/or seek the guidance of an asbestos professional.
