## Safety Alert

# Serious crush injury highlights lack of risk assessment of plant

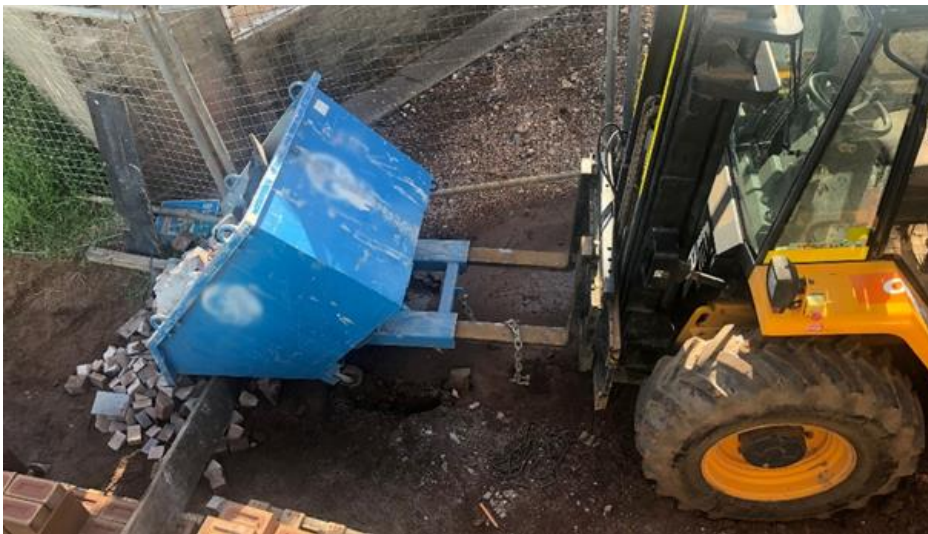
A worker received serious crush injuries when a self-dumping bin full of building rubble tipped forward onto his leg. The worker was standing in front of the bin when it tipped forward.

Image 1: The forklift tines were not fully inserted into the bin pockets.

- Ensure that risk assessments are carried out on all plant and machinery, including attachments, operated in the workplace to identify, assess and control all hazards to which people are likely to be exposed to;
- Safe systems of work should be developed and all operators should be trained in the operation of the plant or equipment they are using;
- Ensure the manufacturer's instructions are provided with any equipment on-site;
- The bin should be placed on the ground before workers start loading the bin;
- If the bin is elevated on the forklift, the tipping path of the bin should be an exclusion zone for workers.

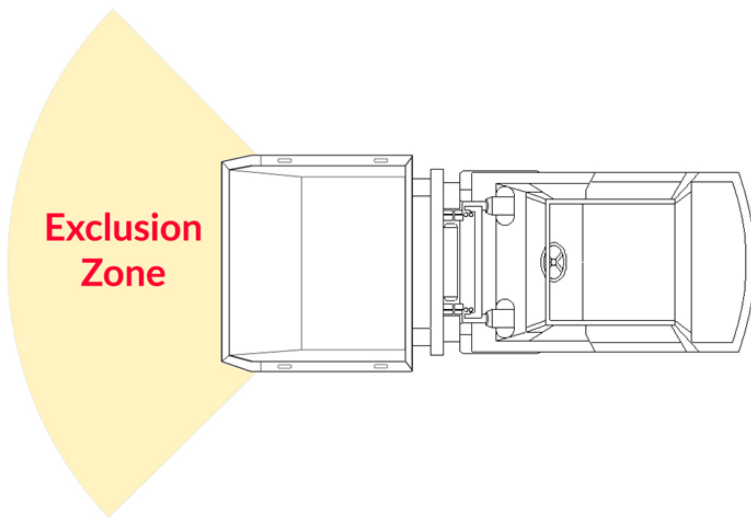
Figure 1: The tipping path of the bin should be an exclusion zone for workers.
