Safety Alert

Worker seriously injured after fall from make shift forklift workbox

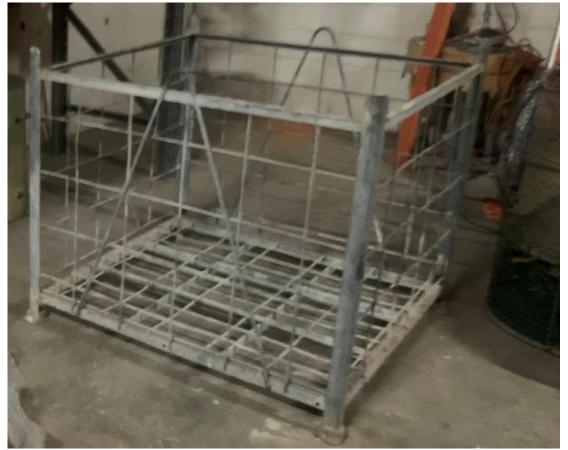
Preliminary findings indicate the worker's weight may have shifted causing the mesh storage cage to unbalance and fall.

Image: The mesh storage cage used was not a suitable forklift workbox.

- The mesh storage cage used was not fit for purpose as a workbox for workers to work from
- The mesh storage cage was not secured to the forklift.
- The worker was not wearing a safety harness.
- The forklift operator had exited the forklift when the incident occurred.

- Only use workboxes and other forklift attachments that have been designed by a competent engineer and manufactured by a competent person.
- Workboxes should only be used on forklifts with a load capacity data plate stating attachments may be used.
- Workboxes must be securely attached to the forklift and should only be used to lift workers for short term tasks.
- Ensure workers are trained in the safe use of workboxes including emergency procedures to ensure occupants can be rescued if an incident or breakdown occurs.
- Workbox occupants should wear a safety harness if there is a risk of them falling.
