Safety Alert

Check for asbestos damage after severe weather event

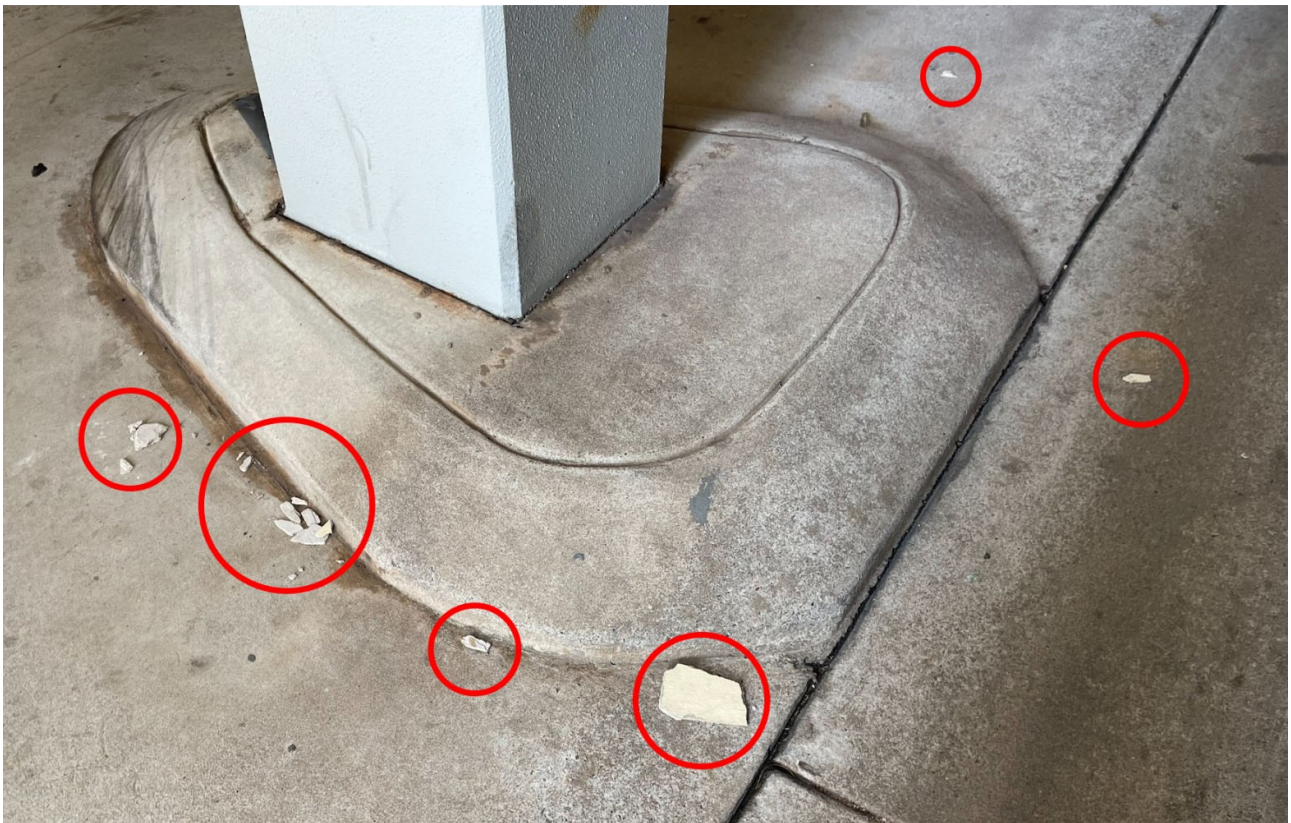
Fragments of ACM were found outside a commercial building in Darwin after it was damaged during Cyclone Fina.

Although workers inspected the building for cyclone damage, they overlooked the ACM outside. It remained there for several days before being removed. Delaying the cleanup may allow further damage to the fragments potentially releasing harmful asbestos fibres.

Image: Small pieces (fragments) of ACM at the entrance of a building's carpark.

- ACM in existing buildings are now 30 years or older, and this aging material could be deteriorating.
- Severe weather events, like a cyclone can damage ACM, especially if the ACM is located on the outside of the building.

- The workers who checked for damage to the building were not specifically looking for damage to ACM.

- Commercial property owners should conduct visual inspections on ACM in their property after severe weather events, such as a cyclone.
 - Provide a copy of the building's asbestos register to workers so they are aware of the location of the buildings ACM and what damage to look for after a severe weather event.
 - Provide asbestos awareness training to workers who would be involved in the identification of debris and clean up after a severe weather event.
- Take appropriate action to manage damaged ACM as detailed in your asbestos management plan.
