Safety Alert

Asbestos found in external and internal render

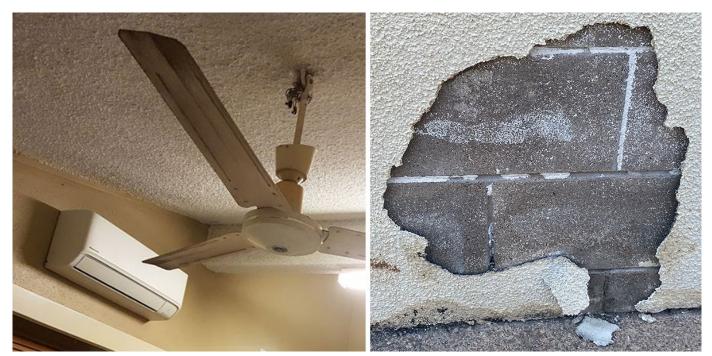
In the first incident, contractors engaged to demolish an old commercial building conducted sampling and asbestos testing before they commenced work. A sample of the buildings external cement render returned positive for asbestos despite the external render not being listed as a location for asbestos in the building asbestos register. Additional sampling and testing of the external render from around the building all returned positive results.

In the second incident, contractors renovating a residential house drilled into a concrete ceiling which had a vermiculite coating. Vermiculite is a spray-on textured ceiling finish popularly used in the 1970's to early 80's. Asbestos has previously been found in some vermiculite. The concerned homeowner had a licensed asbestos assessor test the vermiculite which returned positive for asbestos. At least six workers and the homeowner have potentially been exposed to asbestos fibres.

Image: The asbestos containing vermiculite (left). The asbestos containing external render (right).

- The asbestos register for the commercial building did not list the external render as containing asbestos as the person creating the register may not have sampled and tested the render as they didn't think it would contain asbestos.
- The contractors renovating the residential house did not think the vermiculite coating would contain asbestos and did not sample and test. Not all vermiculite contains asbestos.

- All businesses and workers contracted to work on buildings built or renovated before 1990, should follow the <u>How to manage and control asbestos in the workplace</u> Code of Practice.
- It is recommended that a <u>licenced asbestos removalist</u> or <u>licensed asbestos assessor</u> be engaged to assist with identification, sampling and testing of potential asbestos and asbestos containing material in the work area before work commences.
- Products or material, that could be asbestos, likely to be disturbed by your works, that are not listed in the asbestos register, should be treated as asbestos until testing confirms otherwise.
